# DETECTING BOLT LOOSENING ON THE BASIS OF VIBRATION SIGNALS AS LOW AS A FEW HERTZ

NORITAKA YUSA<sup>1</sup> AND SAKUO SAWADA<sup>2</sup>

<sup>1</sup> DEPARTMENT OF QUANTUM SCIENCE AND ENERGY ENGINEERING,  
TOHOKU UNIVERSITY

<sup>2</sup> SAWADA TECHNICAL SERVICE CO., LTD.

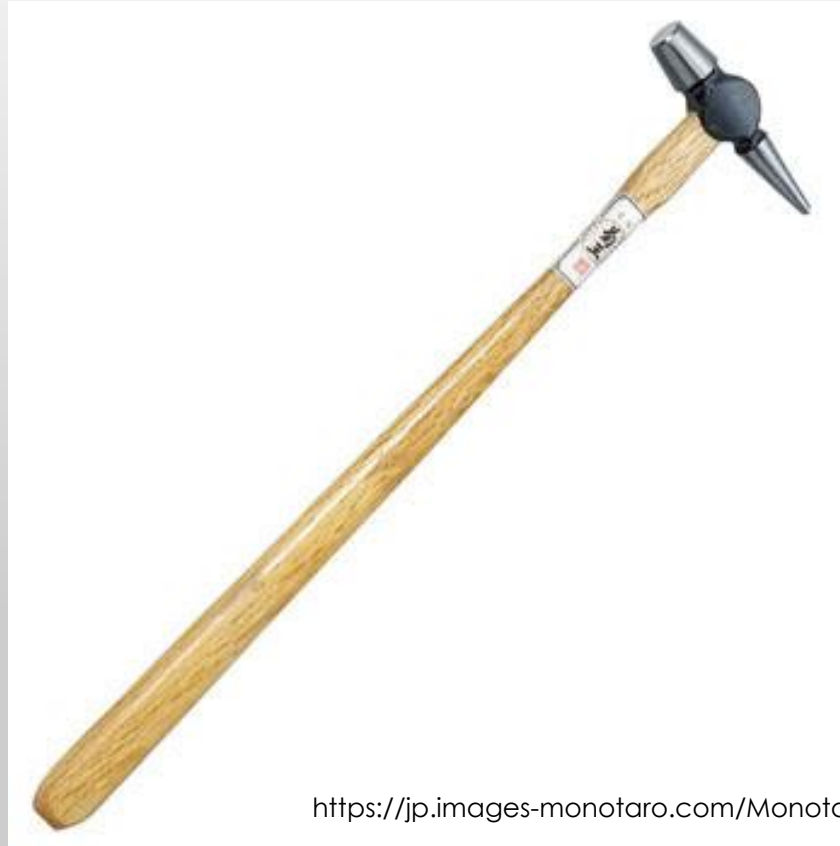
## CONVENTIONAL METHOD: IMPACT TEST

Simple, but not so objective or quantitative
